AIR FORCE REUSABLE ROCKET ENGINE PROGRAM

XLR129-P-1

FINAL REPORT

AFRPL-TR-71-1 VOL II

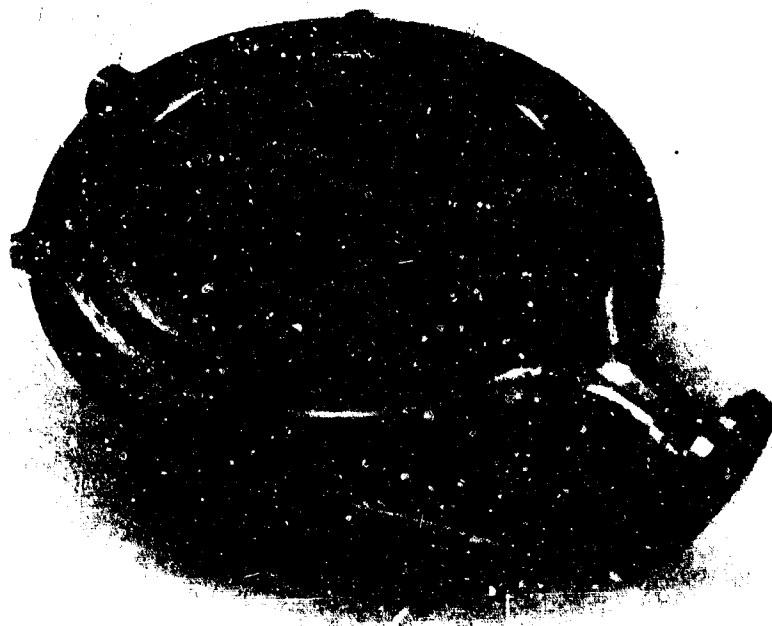
Two preburner injector housings were fabricated by a vendor. The major parts of the housing are the wraparound manifold outer halves, inlet horn, inlet transition, and the housing body, shown assembled in figure 356. Each of these subassemblies was machined from Inconel 718 forgings in solution condition and welded.

Figure 356. Injector Housing Fabricated by Vendor FE 86397

The integrity of the welds was assured by X-ray after the root weld pass. On the first injector housing two small areas of weld porosity were found by X-ray of the root pass. These spots were routed out, welded, and re-X-rayed. The second X-ray revealed the welds to be good. The housing vendor also fabricated the divider plate and fuel faceplate to ensure alignment of each hole and avoid any problem in assembly around the element.

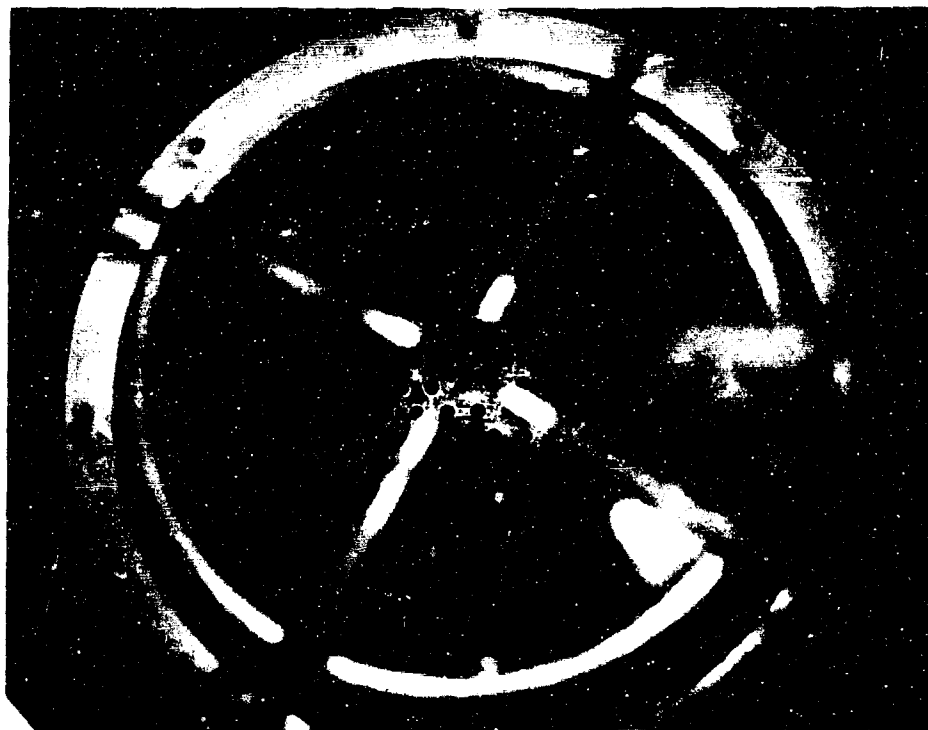
Figure 425. Injector Face Showing Eroded Areas FE 95672

Run 11.01, conducted on February 11, 1970, was a full duration run of 35 sec. Inspection of the rig after shutdown did not reveal any damage. Figure 425 shows the injector face. As can be seen in the photograph, the eroded areas on the injector face do not constitute any problem. Conditions attained on test 11.01 are shown in tables XLVII, XLVIII, and XLIX. The conditions attained are close to prediction except for the leak into the secondary cavity causing an incorrect flowsplit. The temperature profile is an acceptable 173°R maximum-to-average temperature at 2106°R average. The temperature distribution retains the characteristic shape as shown in figures 426 and 427. Liner temperature during the mixture ratio excursion at 50% remained at or near the average combustion temperature, also shown in figure 427.

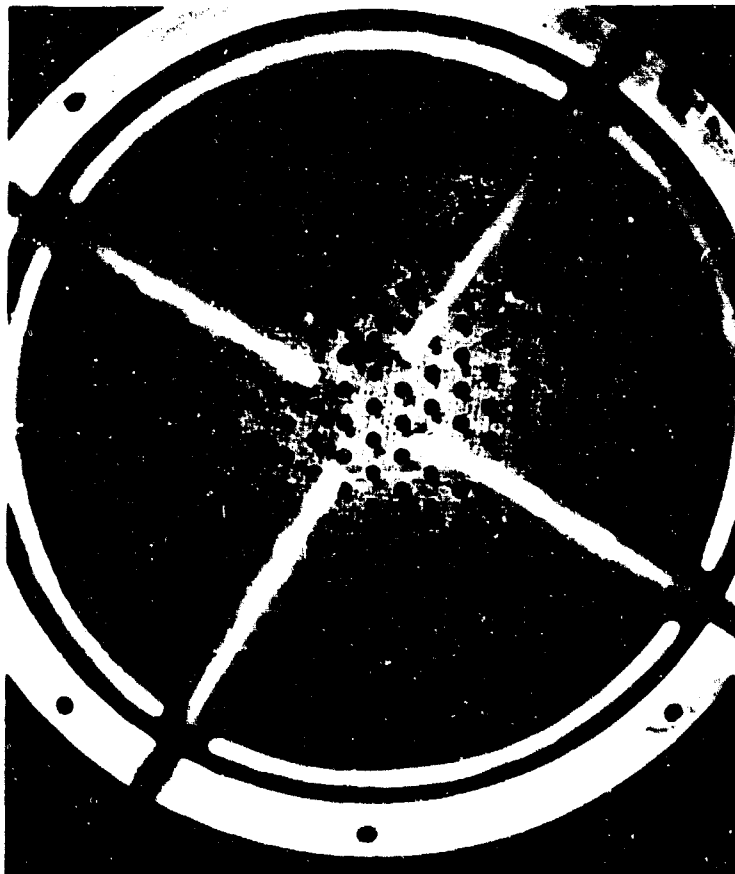
Figure 436. Injector Face Shown After Run 14.01

Visual examination was conducted on both the Rigimesh plate and the injector oxidizer elements after faceplate removal. No information was gained from the Rigimesh plate as the area was inaccessible to visual examination. Visual and binocular examination of the braze joint location on the oxidizer element was in general very difficult if not impossible due to the configuration of the part. As there was this hinderance to direct observation, those areas which appeared to show the most promise by visual examination were replicated with plastic for easier access. These replicas of the areas of the failed joints were examined both by light microscopy and electron microscopy. One condition observed on all the samples was evidence of etching or corrosion, indicating that the protective wax masking was not completely effective.

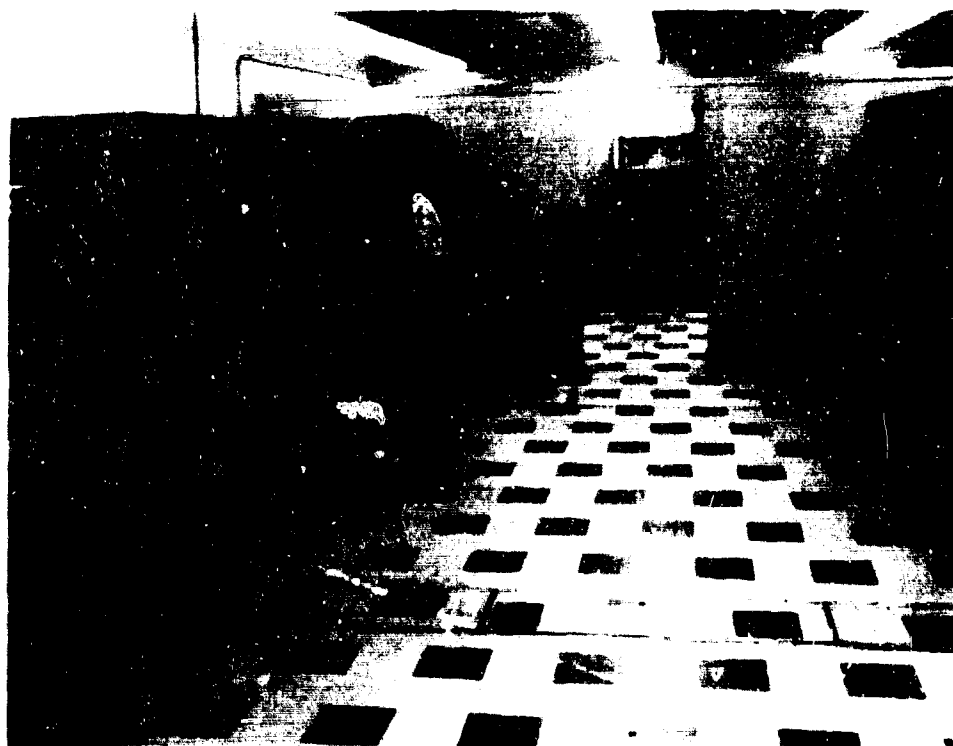
Figure 473. 300-Channel Digital Data System

Analog tape	24 channels
Digital recording	200 channels
Oscillograph (control parameters)	18 channels

In addition there are nine high speed camera locations and closed circuit TV for test monitoring.

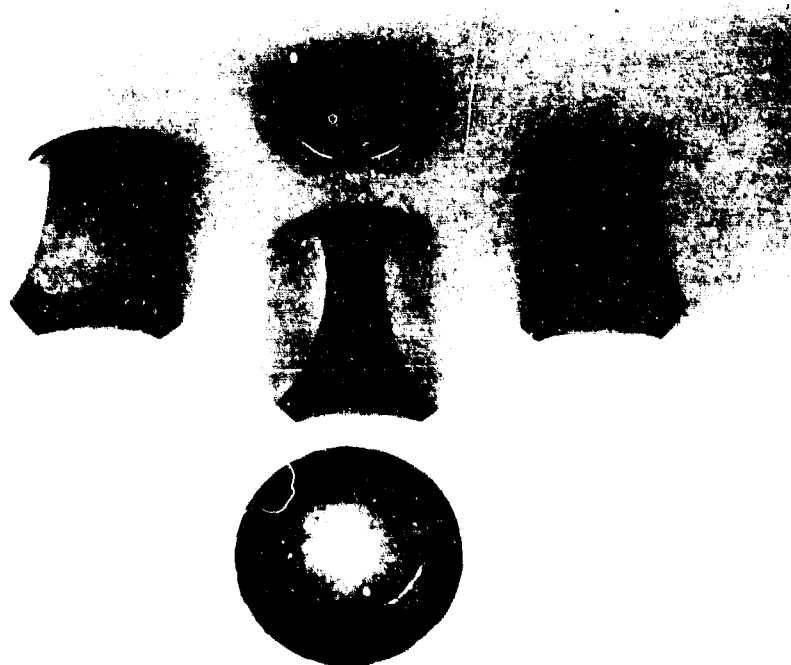
Figure 482. Details of Cooled Liner Assembly

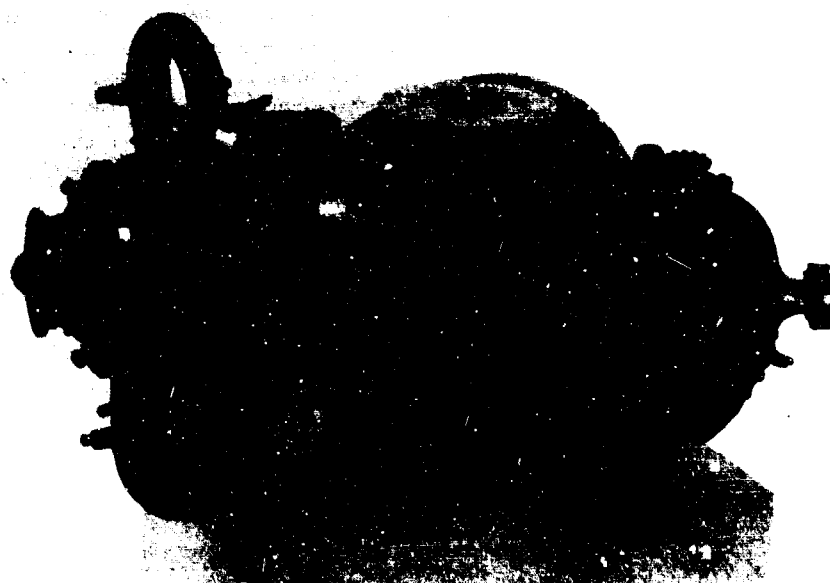
Figure 489. Transition Mockup Assembly Showing Preburner Injector and Fuel Pump Installation FE 96289

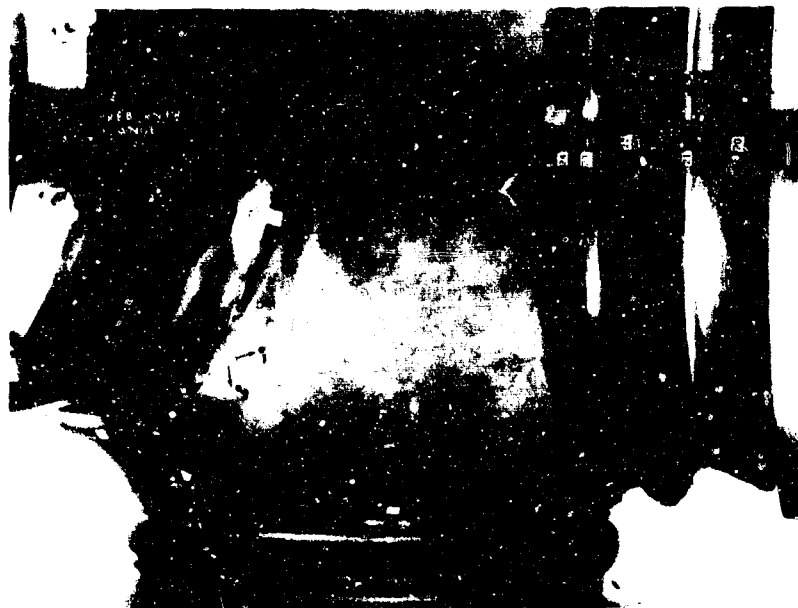
Figure 494. Advanced Propulsion XLR129
Preburner Outer Case Showing
Locations of Strain Gage Rosettes
No. 20 through 24, 37, 38, 39, and
42. (2147902 S/N 1)

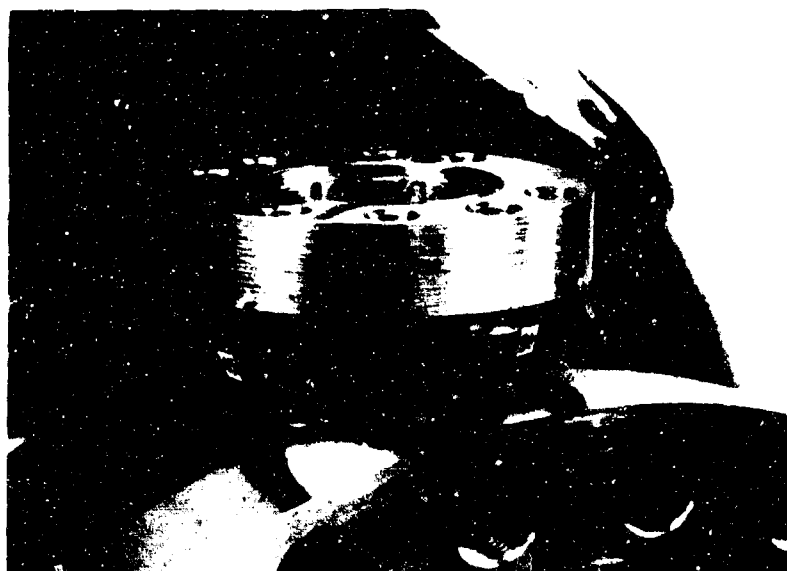
Figure 498. Advanced Propulsion XLR129
Preburner Outer Case Showing
Locations of Strain Gage Rosettes
No. 45 and 46. (2147902 S/N 1)

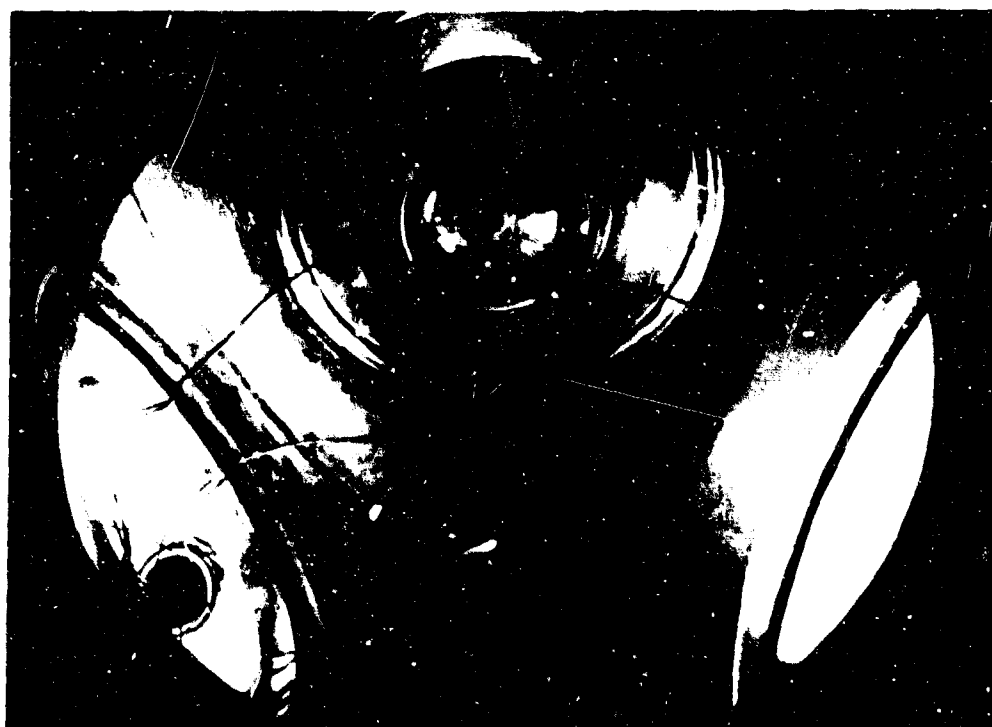
Figure 503. Outer Case and Porous Cooling Liner
Instrumentation

Following the proof pressure test, the preburner sphere area of the assembly was gold coated to reduce radiation effects from the preburner duct. Instrumentation to monitor conditions in the cavity between the outer case and porous cooling liner were applied to the case as shown in figure 503.

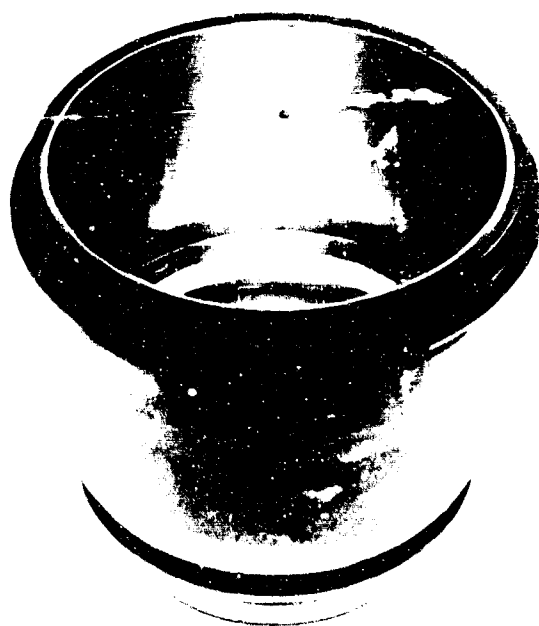
Figure 508. Preburner Combustor Duct Braze
Assembly

The inner liner contains 60 longitudinal coolant passages approximately 0.260 in. wide x 0.060 in. deep, contour-milled into the outer surface. Before mating the inner and outer duct to form the major portion of the preburner duct, each duct was silver flashed (AMS 2666) to provide braze material. After assembly of the inner duct to the outer duct, which is a tight fit, the assembly was oven brazed. The slots that were milled in the inner duct formed cooling passages. The inner and outer ducts are shown before brazing in figure 507. Because the braze is loaded in compression, it is not critical as far as strength and coverage are concerned. Flow checks indicated the slots to be unobstructed, and braze coverage, where desired, exceeded 90%. Figure 508 shows the brazed assembly.

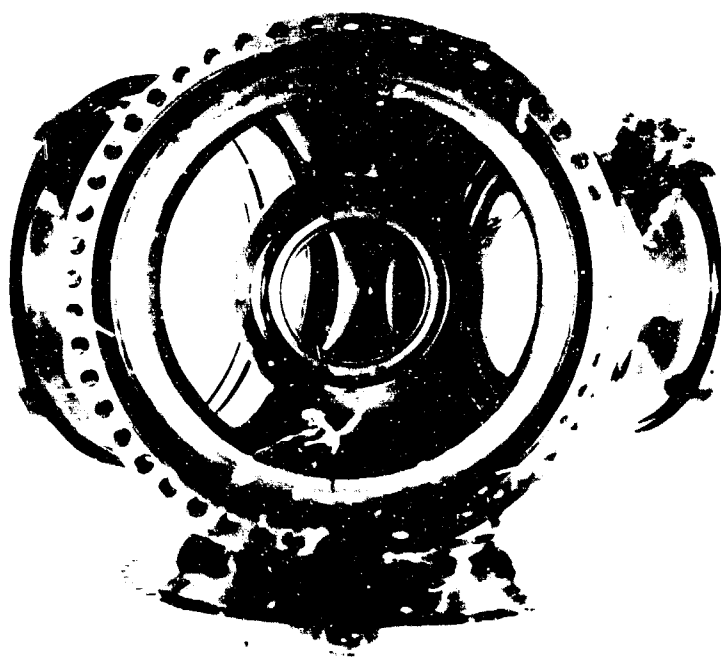
Figure 510. Transition Case With Centerbody Installed FE 97796

The outermost shell is a porous liner similar to the outer case cooling liner. Its purpose is to protect the structure of the centerbody from the hot turbine exhaust gases. The centerbody is supported by the transition case at the gimbal support cone through a threaded joint. Coolant supplied to the centerbody from the transition case flows through this threaded joint, cooling the area of the gimbal before entering the centerbody. A spherical volume is provided between the cooling liner and structure to allow coolant flow to circulate and discharge into the flow stream. Similar to the transition outer case porous cooling liner, the coolant liner flow is tailored by flame-spraying to allow the designed flow rate and pressure differential. The structural sphere and rings are composed of Inconel 718. The outer porous liner is made of N-155 wire. Subassembly of the structural segment and cooling liner details are shown in figure 509. A complete centerbody assembly is shown in figure 510, installed in the outer case.

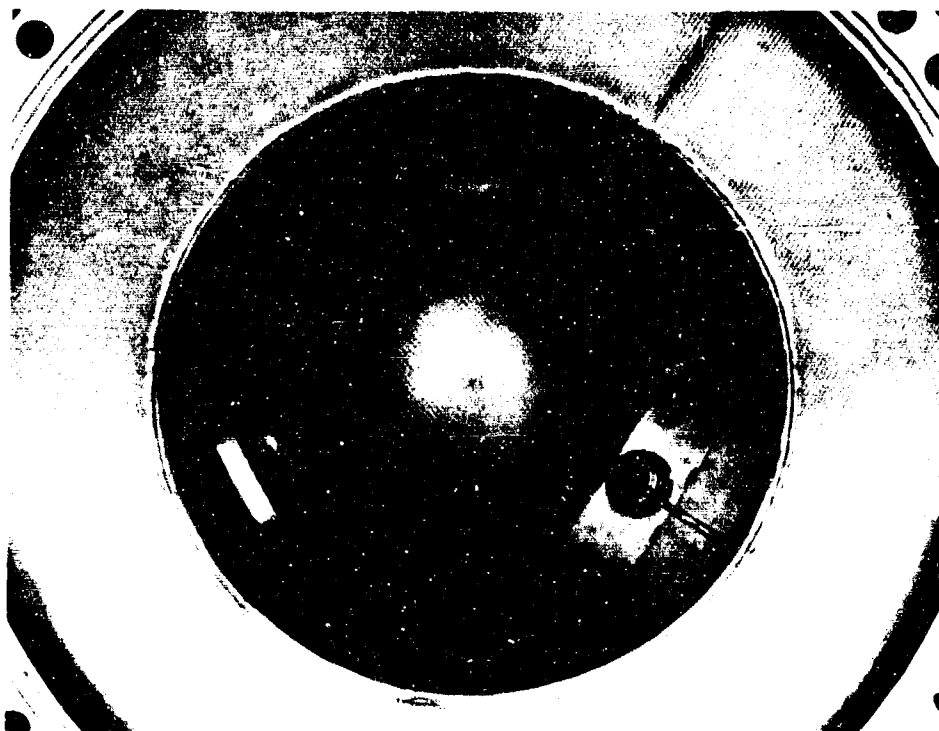
Figure 512. Transition Case Assembly Viewed Through Main Injector Flange

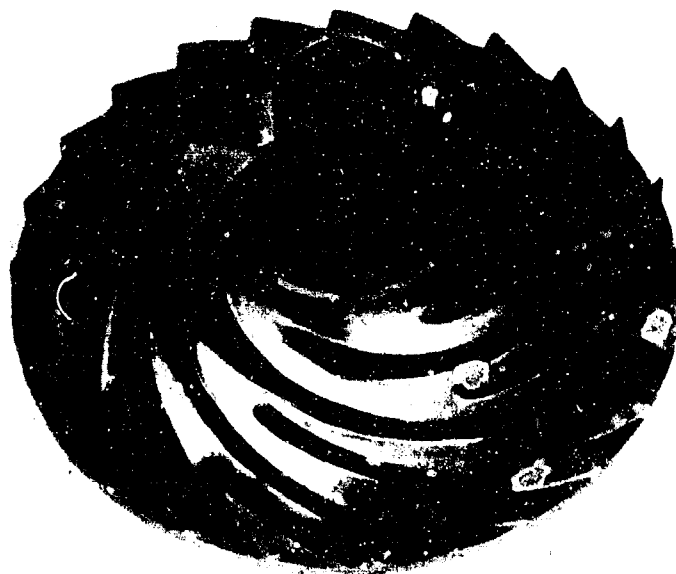
Figure 595. 2nd-Stage Impeller

Impellers for the 1st- and 2nd-stages are fabricated from A-110 titanium closed-die forgings with grain flow orientation following the hub and blade contour. Machining techniques are the same as those employed for the inducer. Figures 594 and 595 show the 1st- and 2nd-stage impellers, respectively, as viewed from the inlet end.

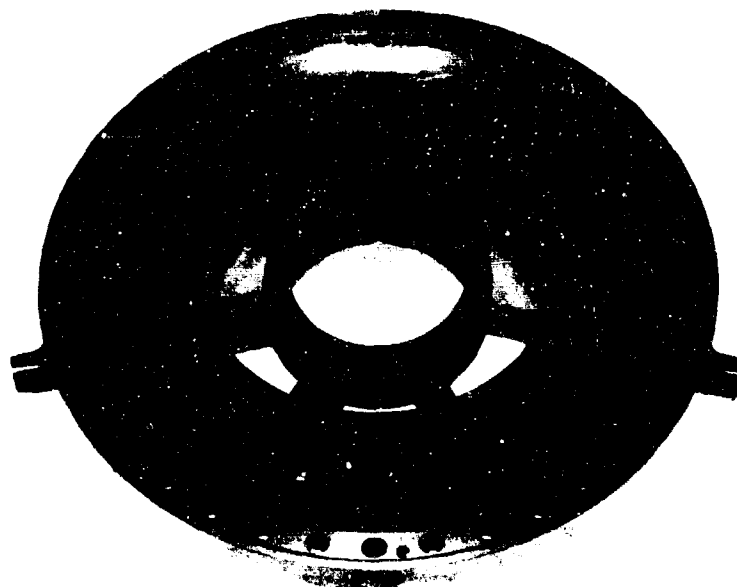
Figure 602. Inducer Housing Assembly (View 2)

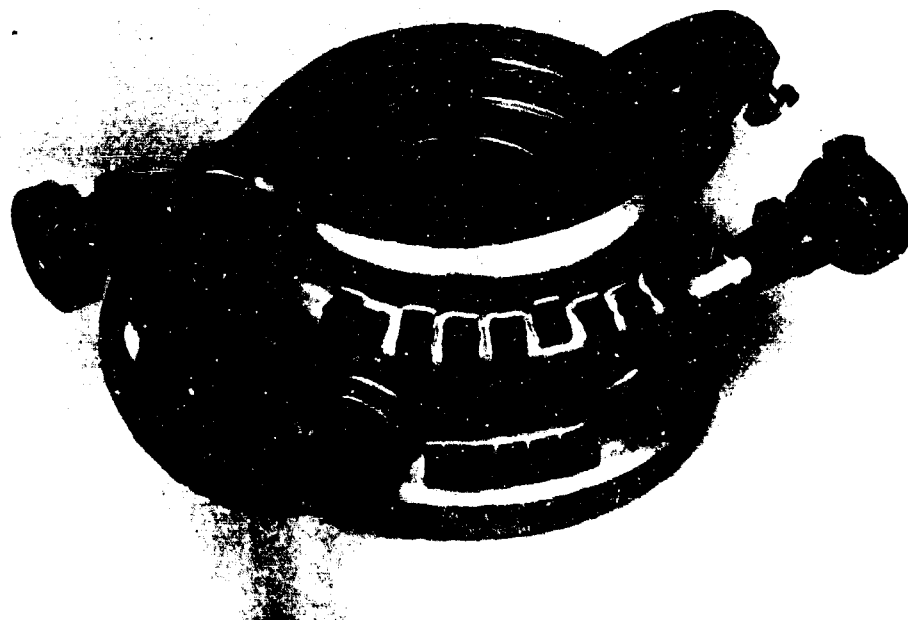
Figure 605. Main Turbopump Housing Machined
to Dimension

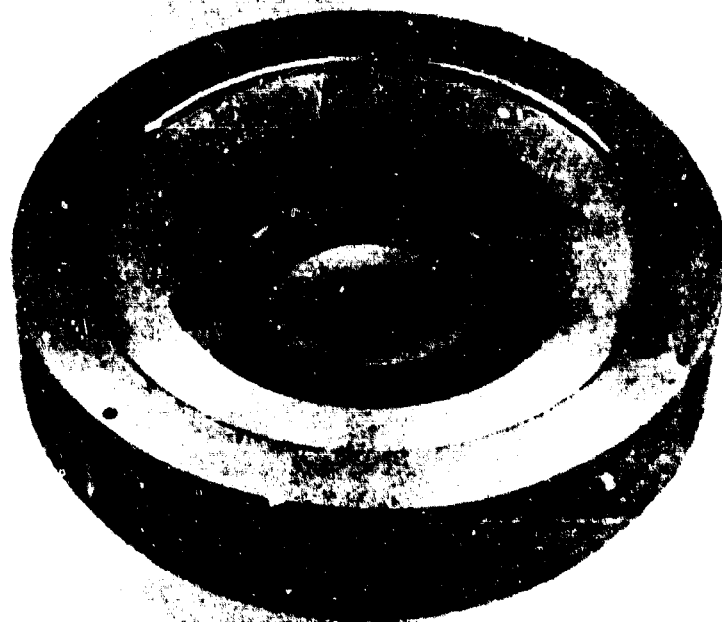
Figure 606. 2nd-Stage Housing After Machining
Operations

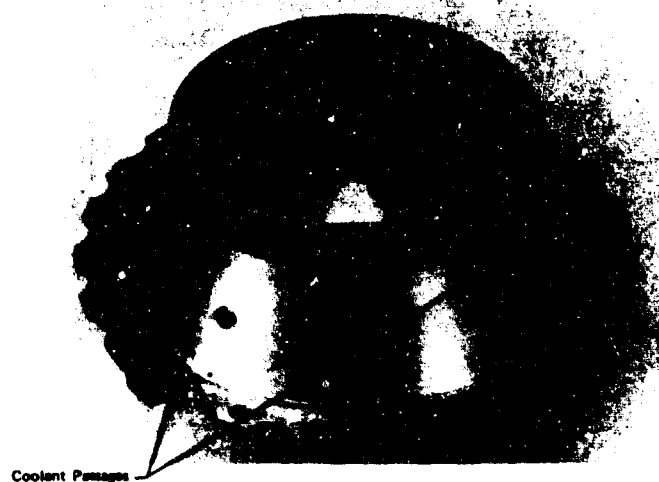
Figure 612. Turbine Inlet Duct - Inlet End at Top FD 38340

The turbine inlet duct assembly consists of the duct structure and the permanently attached flow duct heat shields. The duct was fabricated from an Inconel 718 (AMS 5663) semiclosed die forging. The billet was selected oversized for the closed die form and the hammer stroke was limited. This resulted in an outflow of metal between the hammer and the die face that provided radial grain flow for the outer flange. The strut and internal duct contours were machined on a three dimensional pantograph milling machine by tracing a duplicating master. The thirteen 0.050 in. diameter flow passages were installed in the struts using the EDM method. This method was selected, instead of gun drilling, to maintain the alignment of the holes near the bottom of tool penetration. All 13 holes in each strut were machined in a single pass. This and other machining operations utilized conventional processes. Figures 612 and 613 show the inlet and discharge sides of the turbine inlet duct after completion of final machining.

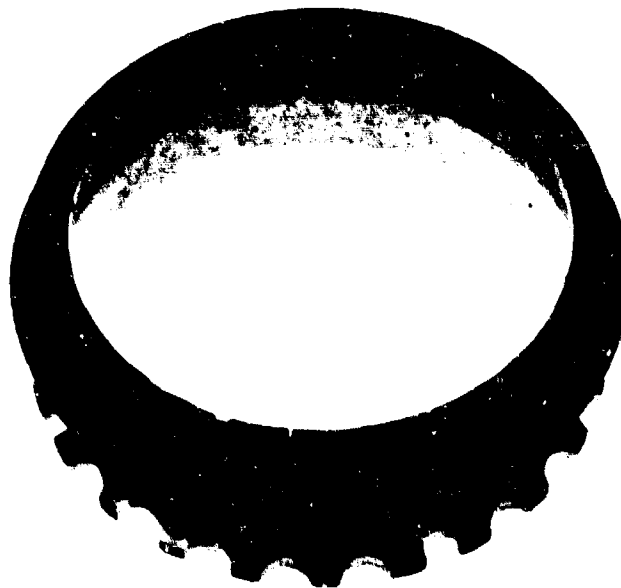
Figure 623. Turbine Support Ring

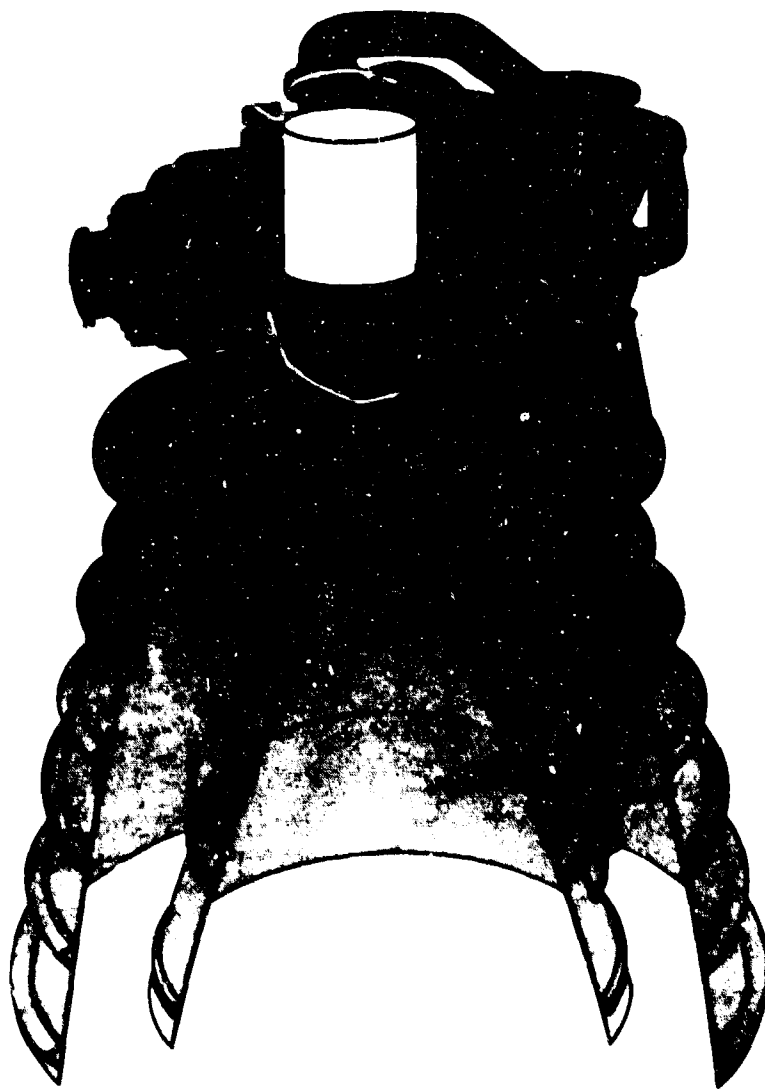
Figure 767. Fuel Low Speed Inducer Location

The fuel low-speed inducer provides fuel to the main turbopump at a pressure sufficient to prevent fuel turbopump cavitation. This permits main pump operation at high speed, saving pump weight. Without the low-speed inducer, high engine inlet pressures are required. The three-bladed, low-speed inducer is driven by a single-stage, partial-admission turbine. The low-speed inducer operates independently of the main turbopump and at a lower speed than the main turbopump. This permits the low-speed inducer to operate at a low inlet pressure.

The fuel low-speed inducer assembly, with the location and major features indicated, is shown in figure 767 and figure 768.
